A FACILITY AND METHOD FOR EVALUATION OF THERMAL PROTECTION

A. M. Stoll, L. R. Munroe, M. A. Chianta,
J. R. Piergallini, and D. E. Zaccaria
Crew Systems Department
NAVAL AIR DEVELOPMENT CENTER
Warminster, Pennsylvania 18974

1 December 1975

PHASE REPORT
AIRTASK A340000/001B/6F51523400
Work Unit No. DS903

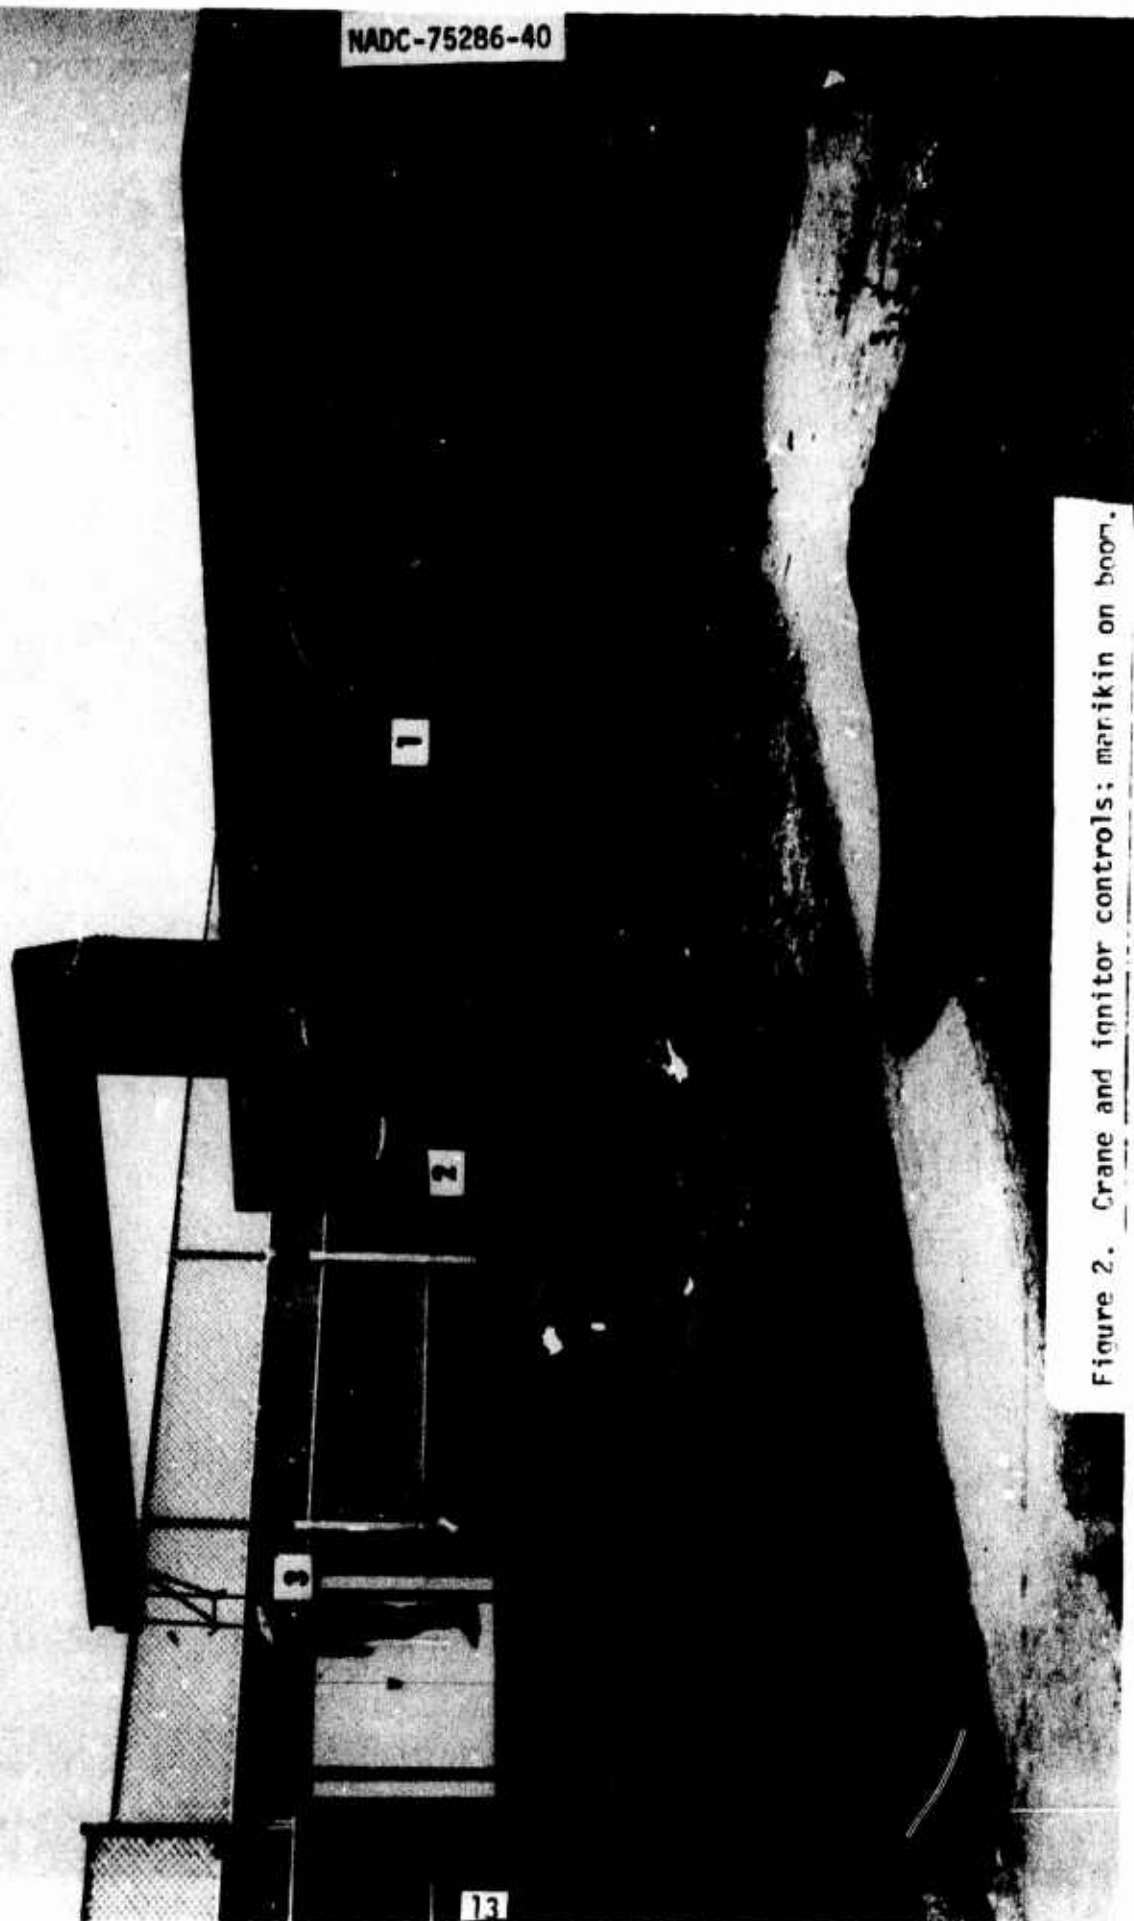
1. Crane actuator switch.
2. Propane - air ignitor fuel system.
3. Manikin (with telemetry disc antenna) suspended from boom.

Figure 2. Crane and ignitor controls; manikin on boom.

The experimental procedure consists of garbing the instrumented manikin in the experimental ensemble, checking the telemetry system, photographing the manikin for record purposes and preparing the pit for firing. The fuel is fed into the pit for 16 seconds at a rate of 0.856 gal/sec (3.24 l/sec) (total 13.7 gal or 51.85 l) and ignition is initiated at 40 seconds, when the fuel has spread completely over the water surface of each compartment. At 48 seconds, the crane is actuated to move the manikin through the flames, which at this

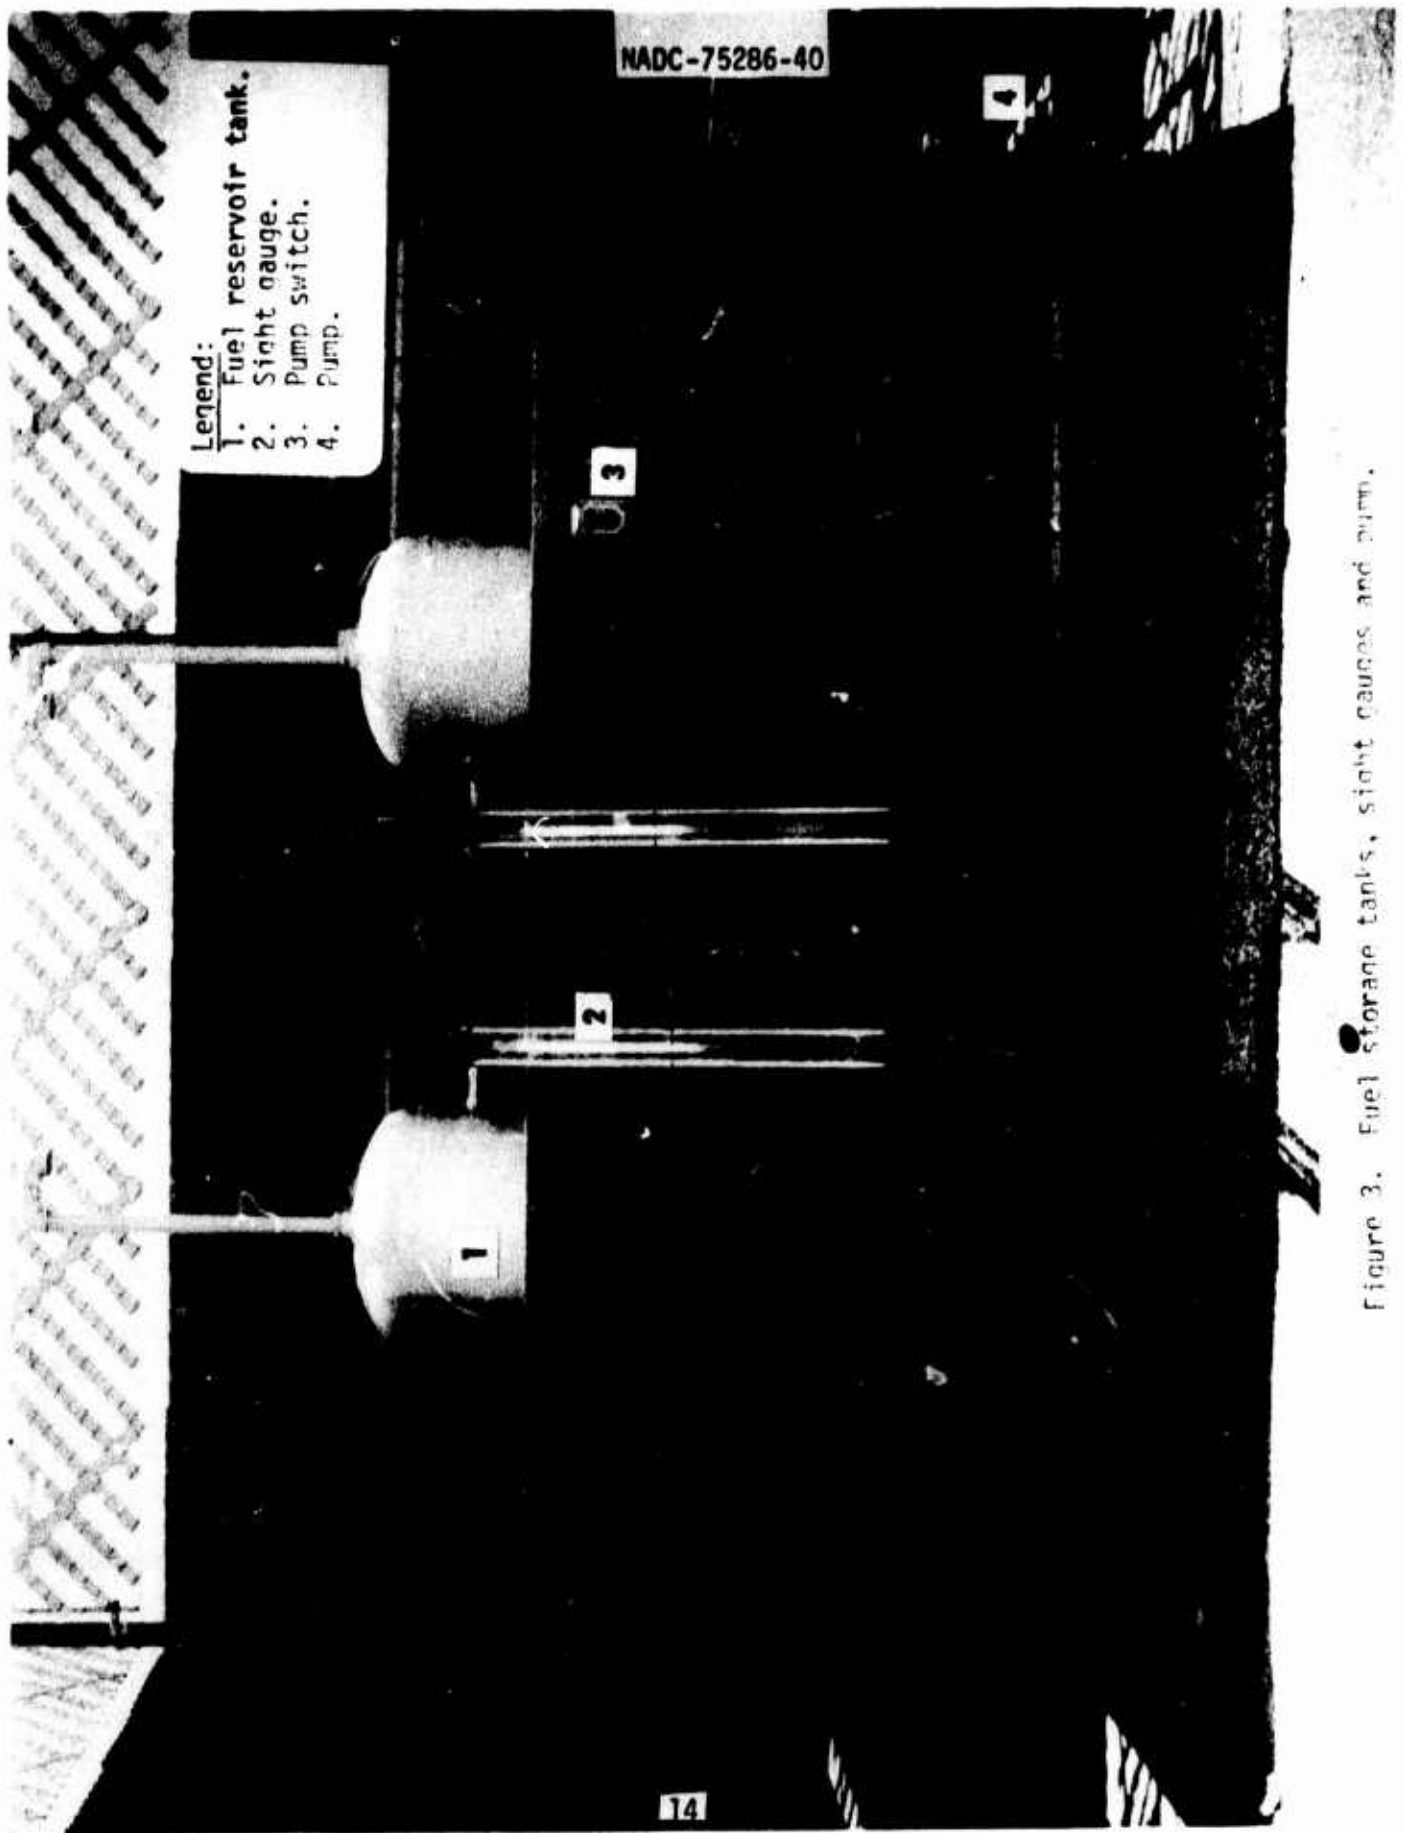
Figure 3. Fuel storage tanks, sight gauges and pump.

The NADC fuel fire pit is housed in an enclosure, approximately 75x75 ft. (22.9x22.9 m), formed by galvanized steel sections 8 ft. (2.4 m) high, surmounted by 4 ft. (1.2 m) of chain link fencing. The fencing is slotted to provide partially open obstruction to wind currents rolling over the top of the solid lower portion of the walls. This open-work has the effect of breaking up the wind front before it reaches the pit itself. Portable screens, 4x8 ft. (1.2x2.4 m) are also available to reduce this effect, if need be. The fuel pit is 20x25 ft. (6.1x7.6 m), 8 inches (20.3 cm) deep, equipped with a fuel dispersion system and a grating to divide the surface into 20 equal compartments (Fig. 1). The dispersion system supplies fuel to each compartment from nozzles submerged in water which provides a base for the fuel. The grating protrudes $\frac{1}{4}$ - $\frac{1}{2}$ inch (0.63-1.27 cm) above the surface of the fuel after dispersion. The purpose of the system is to provide even distribution of the fuel initially while the grating prevents pooling of the fuel under the influence of wind. Four ignitors, fed by a propane and air mixture are mounted at two sides of the pit to emit 18-inch flames which ignite the fuel at the four positions simultaneously. A protective wall is placed along one side of the pit between it and the crane rotor. On the back of this wall are mounted the electrical controls for actuation of the ignitors and the crane (Fig. 2). In Figure 2 can be seen also, suspended from the 20 ft. (6.1 m) boom of the crane, a clothed manikin with the telemetry antenna attached to the neck region. The distance of the manikin from the center of the crane determines the speed at which the manikin is moved across the pit, as the crane operates at a fixed speed. Thus, on actuation, the manikin begins to move from a central position behind the wall. In this way, there is no pre- or post-exposure heating of the manikin and the rate of traverse is a constant 10 ft/sec (3.05 m/sec) through the flames. Figure 3 shows the fuel storage area. Fuel is fed to the dispersion system through underground piping. The flow is at a constant rate and the amount is controlled by the pumping time. The sight gauges are used only to monitor tank filling.

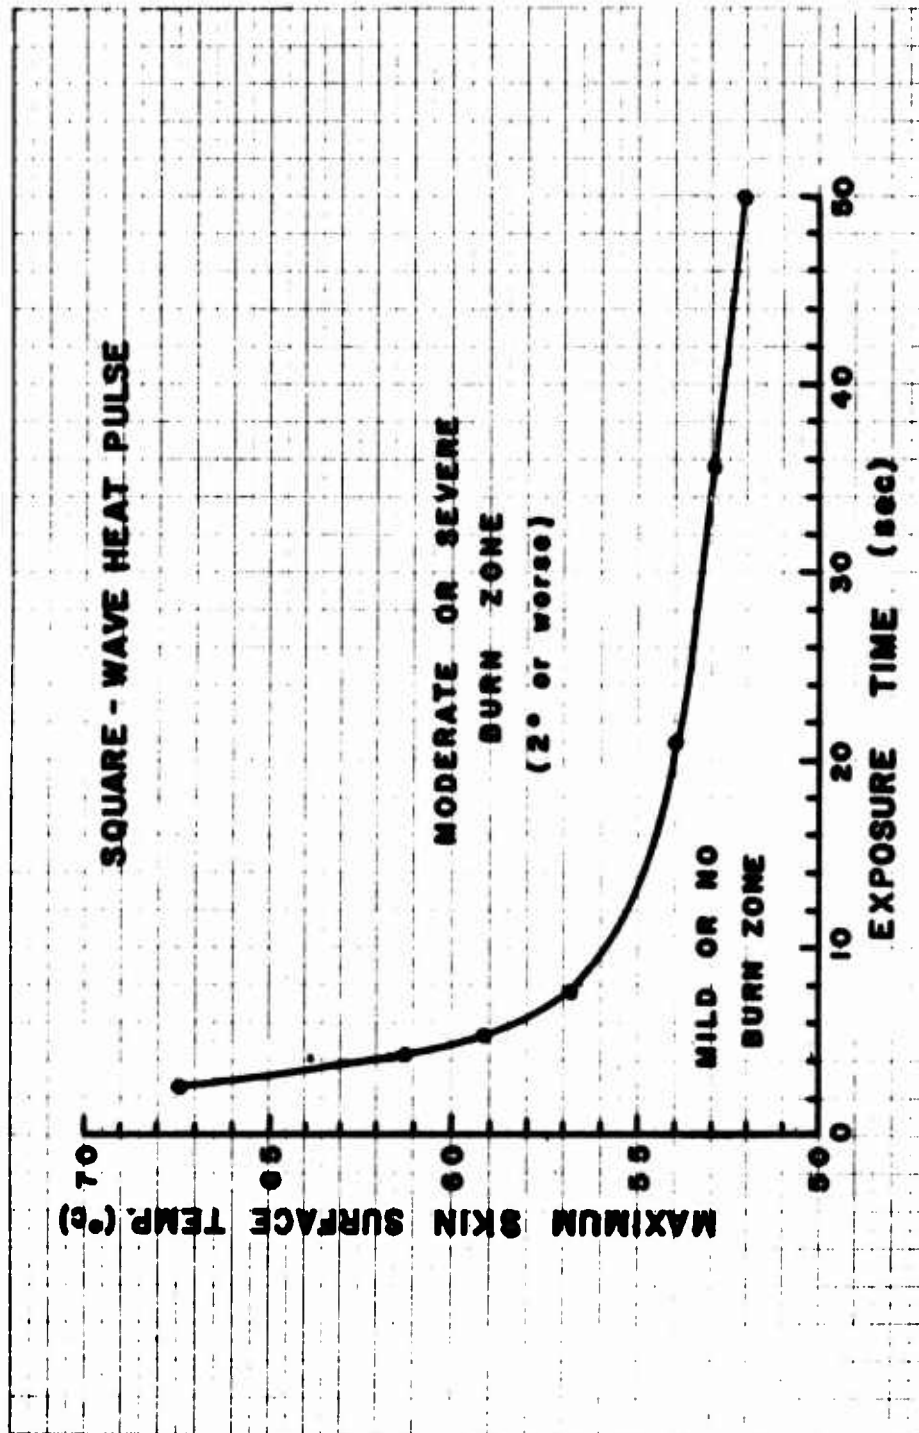
Figure 4. Maximum skin surface temperature occurring on exposure to a square wave pulse of various thermal intensities and duration times causative of blistering.
